**Proceedings of the Second Geo-Institute –  
Kazakhstan Geotechnical Society  
Joint Workshop  
on TC 305  
“Geotechnical Infrastructure for Megacities and New Capitals”**

## Assessment peculiarities of the constructions stability in the areas of affected by mining operations

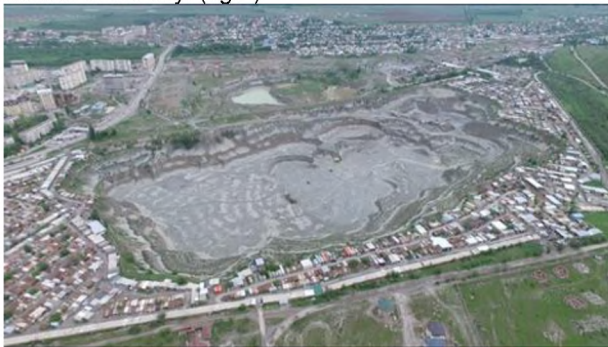
Figure 2. Open pit of non-metallic materials "Sand-Gravel"

The open pit began to be developed in 1968 and functions to this day. The total area of the open pit is 16 hectares, the work is conducted year-round and on average 16-17 tons of dust are emitted into the atmosphere every year.

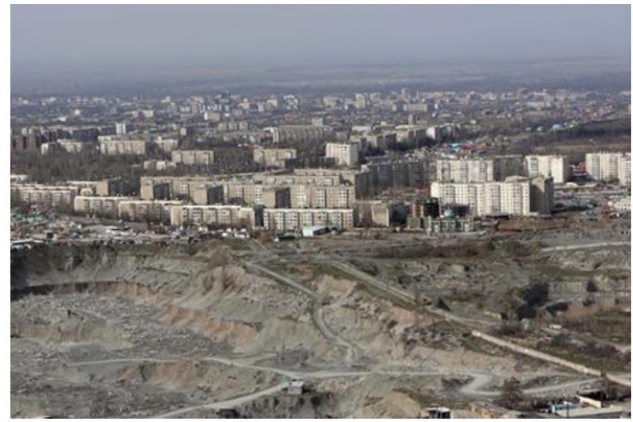
But due to the large flow of residents from the regions to the country's capital, the city is being built and expanding despite, but the obvious danger of living in houses is being built with great risk near the huge excavation pits left after the development of deposits of construction materials. (Fig.3) Because of with these problems, we conducted studies on the features of assessing the stability of the sides of the pit taking into account the building that is under construction.

Figure 3. Buildings of apartment houses near excavations

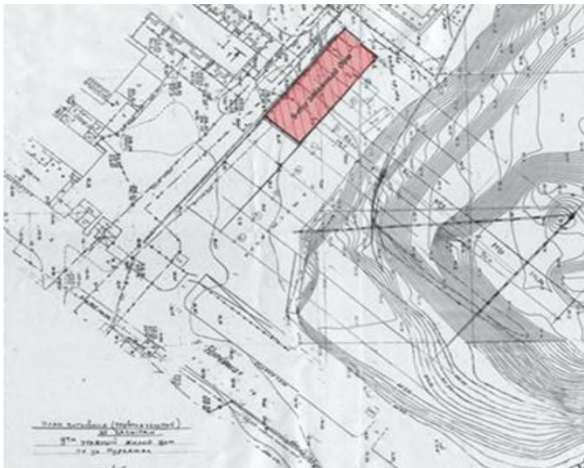
The object of our research was the open pit of constructions materials, located outside the city, the territory of which is equipped with the construction of apartment buildings. The construction of the 9- apartment building is carried out at a distance of 19m from the contour of the side of the pit, (Fig.5) and carries a potential danger to the stability of the foundation of the building. The aim of the research work was to calculate the stability of the pit edges taking into account the building and to reveal the influence of deformation displacements on the foundation of the building.

Figure 5. Topographic plan of the spent pit with indication of a 9-apartment building

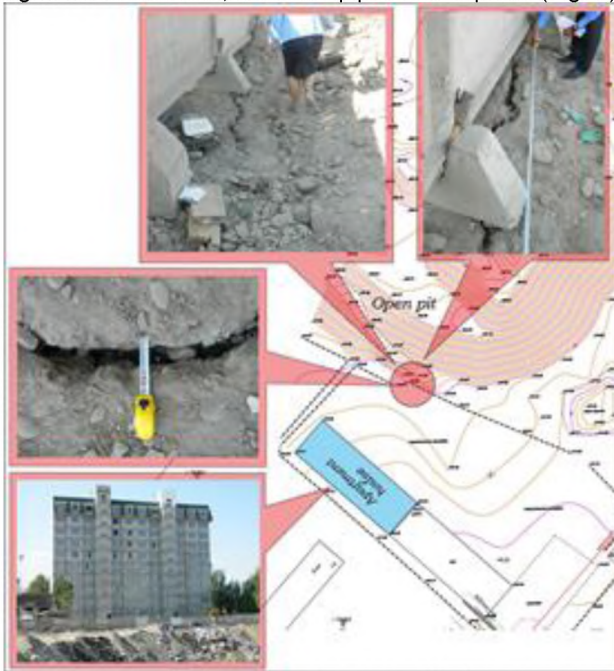
Based on the results of the visual survey of the territory, a crack with an opening of 6 cm from the edge of the pit at a distance of 5-6 m was detected and surface subsidence was observed in this zone. Currently, the backfilling of the pit is carried out with a construction trash: gravel, crushed stone, fragments of concrete, asbestos pipes and asphalt. (Fig. 6)

Figure 6. The topographic plan shows the house under construction and the crack identified.

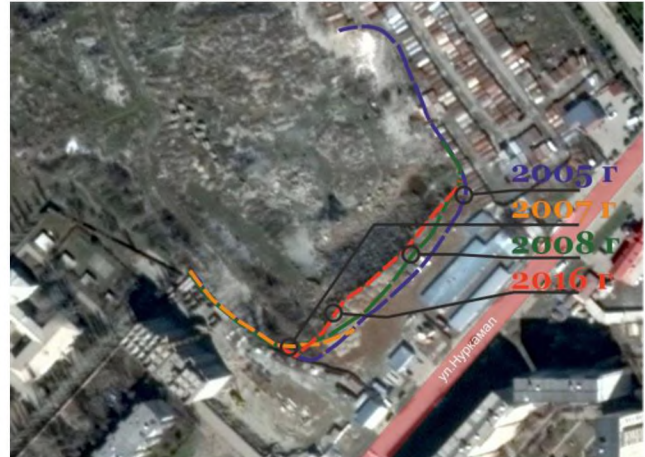
Survey on aerial photographs for changing the parameters of the quarry and the adjacent territory in the periods from 2005-2016. drawings are taken in Google Earth Pro. Early aerial photographs are not available in the archives of Google Earth Pro and do not provide the possibility of visual analysis until 2005. (Fig. 7)

Figure 7. Changes in the parameters of the pit from 2005 to 2016.
